# THE STRUCTURAL BEHAVIOUR OF THE PYRAMID OF CHEPHREN

G. CROCI<sup>1</sup>, M. BIRITOGNOLO<sup>2</sup>

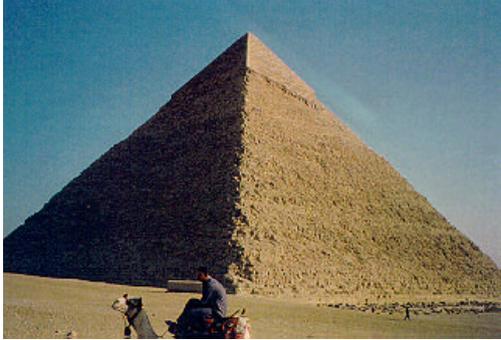
Fig. 1

The Pyramid (Fig. 1) has been built by the Pharaoh Chephren, who was the fourth king of the IV Dynasty (2620-2480 bc.), during the so-called "Old Kingdom". Nearby the Pyramid, Chephren erected also its valley building and mortuary temple, connected with the Sphinx that is thought to be a portrait of the King. The Pyramid has a square basis oriented in such a way to face with each one of its sides one the cardinal points; its original height was of 143.55 mt., and therefore about 3 meters lower than the Great Pyramid (Cheope's Pyramid). The present height of the monument is about 136.39 mt., being missing the very top portion including the capstone. Owing to its position on somewhat higher ground, Chephren's Pyramid creates the illusion of being taller than the Great Pyramid. Formerly each side of the monument measured 215.71 mt.; if faces slope at an angle of  $52^{\circ}20'$  as so they rise more steeply than the faces of the Great Pyramid that is a little higher but has the sides considerably larger.

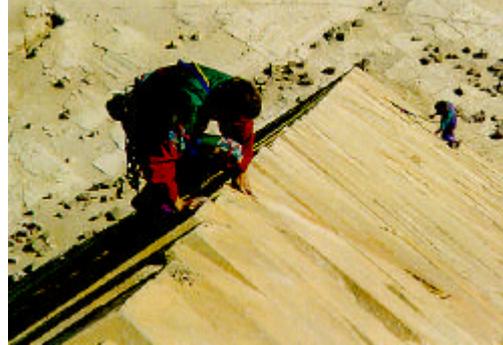
Fig. 2

After two years of researches of documents and studies on the seismic behaviour of the Pyramid, between 17 and 20 November 1994 a climbing and a close survey of the Chephren Pyramid have been carried out accordingly with the relevant Working Plan (Fig. 2). The overall operation has also included the shooting of a tape recorded TV Scientific Documentary, illustrating the different phases of the operation.

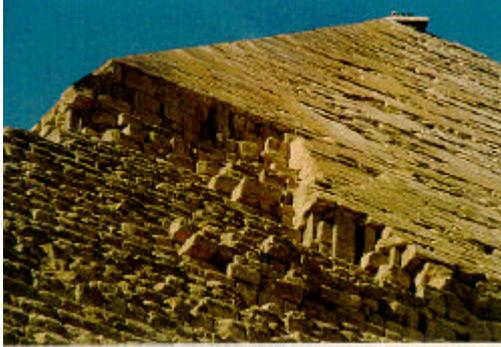
Fig. 4

The reason of this configuration will be explained below. The casing blocks have a horizontal development, and their joints show an exceptional precision of working of the stone faces and contain very thin layers of mortar. The dimensions of the blocks are variable in length and height, as described in the previous paragraph and shown in Fig. 4.

The stone blocks were put away starting from the actual lower border of the casing, as shown by the verticality of the border surface that have been cut using chisels (Fig. 4) After having removed the first rows of blocks it has been very easy to proceed to the dismantling of the other strata from the top to the bottom, not only of the casing but also of the rear elements. The cornice that appears now at the bottom of the medium zone is in reality nothing else that the last level of the utilised quarry.

The ascent of the Pyramid has allowed to immediately answering to the first two questions: The main destruction of the Pyramid is due to having used the monument as a quarry. However, while in the earliest times this destruction has been brutal, without any organisation (lower zone), in the Middle Age the removal of the blocks has followed a precise rational program (middle zone), cutting a row of stones immediately below the present survived casing and realising some little walls and masonry pillars to sustain it (Fig. 4).

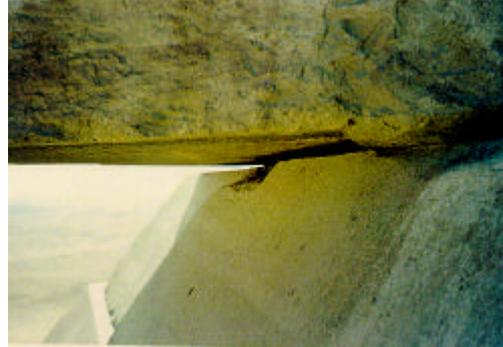
Fig. 5

On the basis of the above results, a local analysis was carried out to check whether the shear forces exceeded the friction strength and consequentially, sliding between blocks could be produced. The results of the analysis revealed that locally, and particularly in the upper zone where the vertical loads are lower, the shear forces, combined with a reduction of the vertical stresses during the earthquake, may exceed the friction strength causing permanent displacements (Fig. 5).

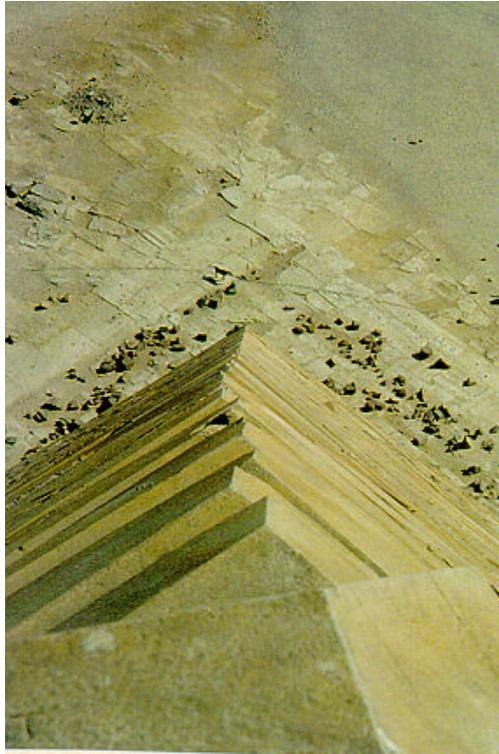
Fig. 6 : Relative movements of the blocks in the corner of the Pyramid

The interpretation of the alternate displacements of the blocks that have been surveyed in the upper part of the corners is more complex (Fig. 6). This phenomenon can be explained by integrating the mathematical results with qualitative considerations, which regard the geometry of the blocks, the horizontal contact surface between them and the position of the applied loads (Fig. 7).

These phenomena contributed to the development, in each corner block, of an eccentricity of the centre of rotation with respect to the barycentre, in which seismic forces were applied creating twisting effects which have caused the observed alternate displacement (Fig. 6).
